**UNITED STATES AIR FORCE  
ELMENDORF AIR FORCE BASE, ALASKA**

LF04 2003 DEBRIS REMOVAL REPORT

FINAL

MARCH 2004

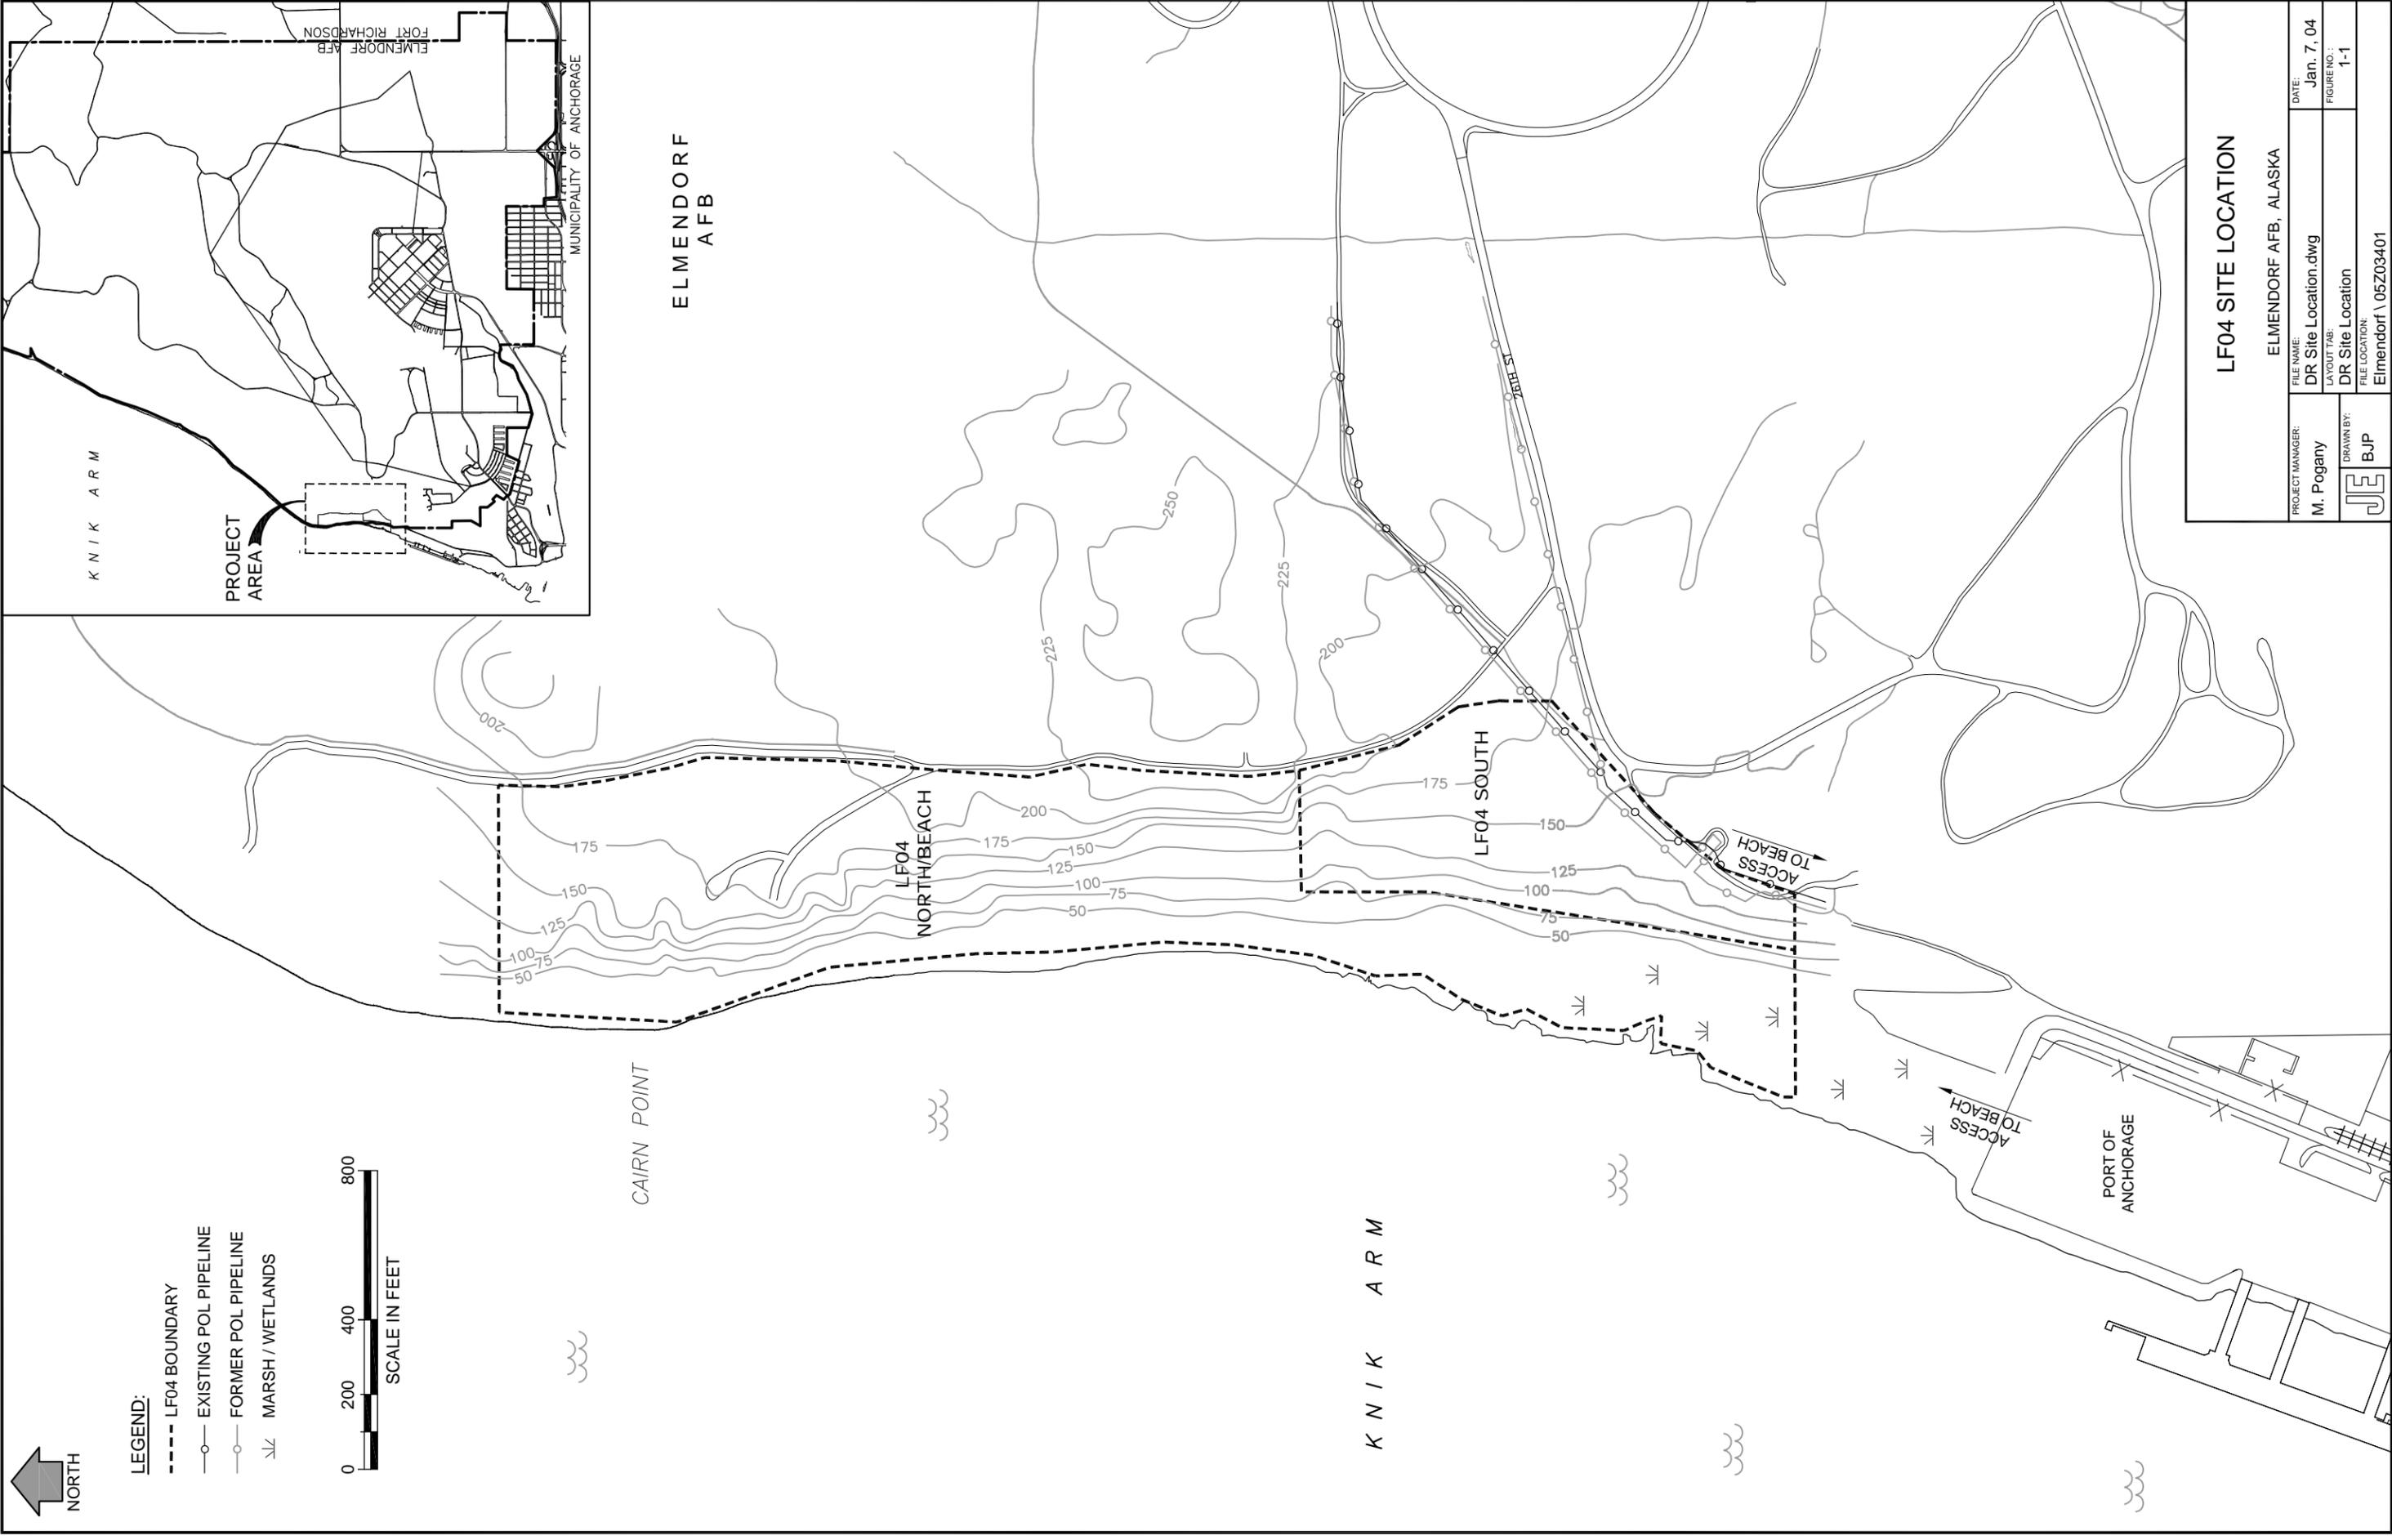
PROJECT MANAGER:		ELMENDORF AFB, ALASKA	
M. Pogany	FILE NAME:	DR Site Location.dwg	DATE: Jan. 7, 04
JE	LAYOUT TAB:	DR Site Location	FIGURE NO.: 1-1
BJP	DRAWN BY:	Elmendorf \ 05Z03401

Source area LF04, the Knik Bluff Landfill, is located on the west side of EAFB (Figure 1-1) and is one of six different source areas within Operable Unit No. 6 (OU6). The landfill parallels Knik Arm for a distance of approximately 3,000 feet and is approximately 600 feet wide. A steep bluff that drops from an elevation in excess of 200 feet down to sea level is located within LF04. Along the southern end of the site, the ground surface slopes toward Knik Arm and the bluff is less pronounced. Several groundwater seeps occur on the Knik Arm Bluff or at the beach.

**LF04 SITE LOCATION**

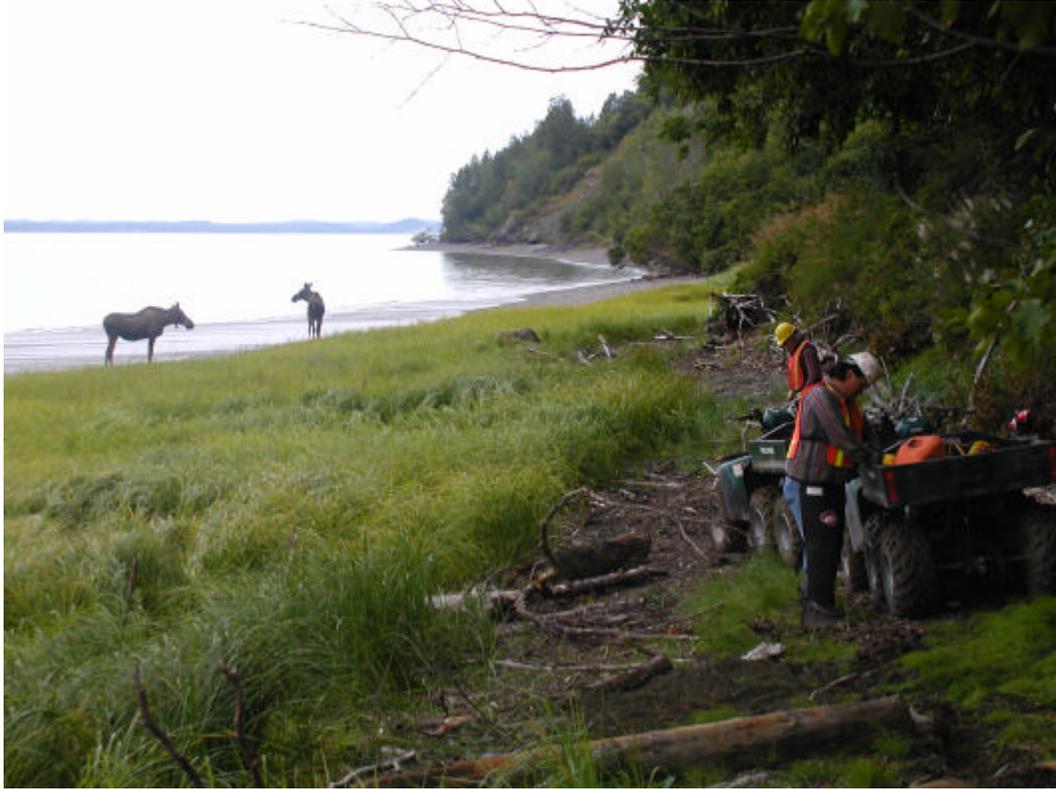
Photo 1 – Clearing Timber and Other Debris from Access

Mobilization for general debris removal occurred during August 2003. ACM was removed under a separate October mobilization. In order to minimize the impact to the coastal habitat, an access path established during a previous debris removal action was utilized during the 2003 debris removal action. Fallen limbs and driftwood timbers identified to be inhibiting access were cleared from the access path. A waste debris transfer area was established in the staging area (Figure 2-1). Demobilization activities included raking the access path to remove minor wheel ruts and replacing some limbs onto the access path to discourage continued access to the LF04 beach area via this route.

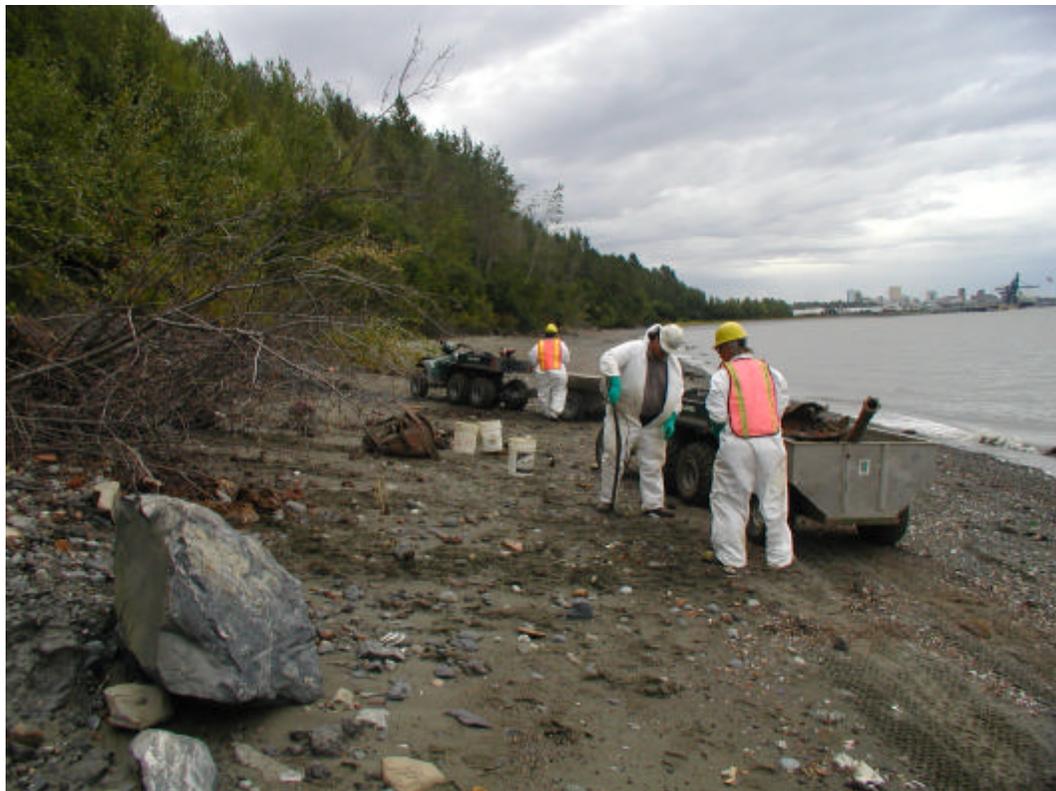
Photo 2 – Gathering Debris From Beach Area

ATVs were used exclusively for removal of non-hazardous debris from the beach area. Since the non-hazardous debris pieces were relatively small, or could be reduced to manageable pieces with minimal effort, debris was gathered from the beach and loaded by hand. Therefore, heavy equipment was not needed to remove any of the non-hazardous debris items. The ATVs followed the gravel beach and access path to limit damage to sensitive site vegetation.

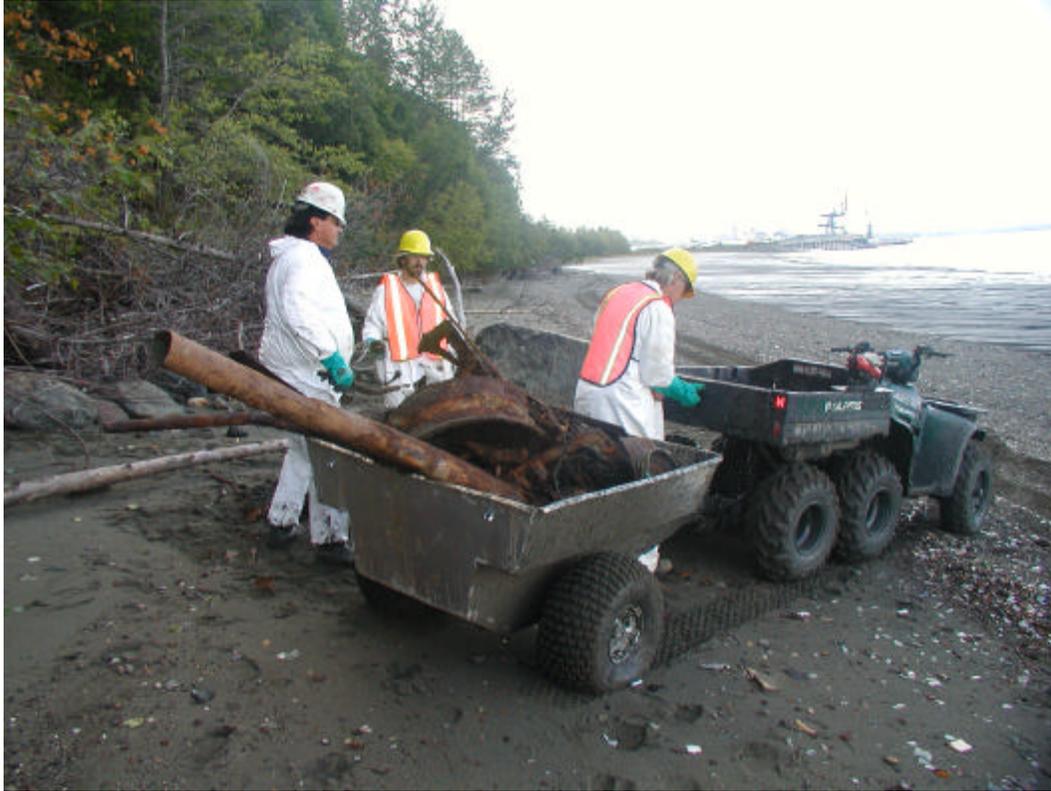
Photo 3 – Loading Debris into ATV and Trailer

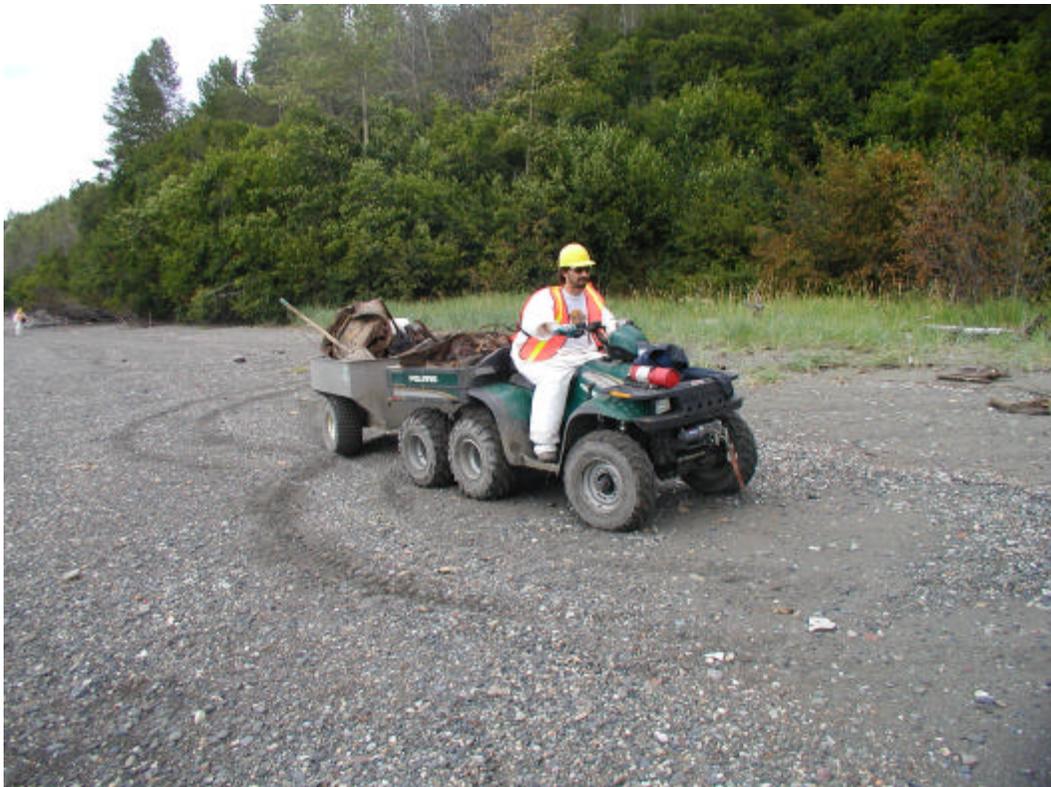
Photo 4 – Transporting Debris on Beach

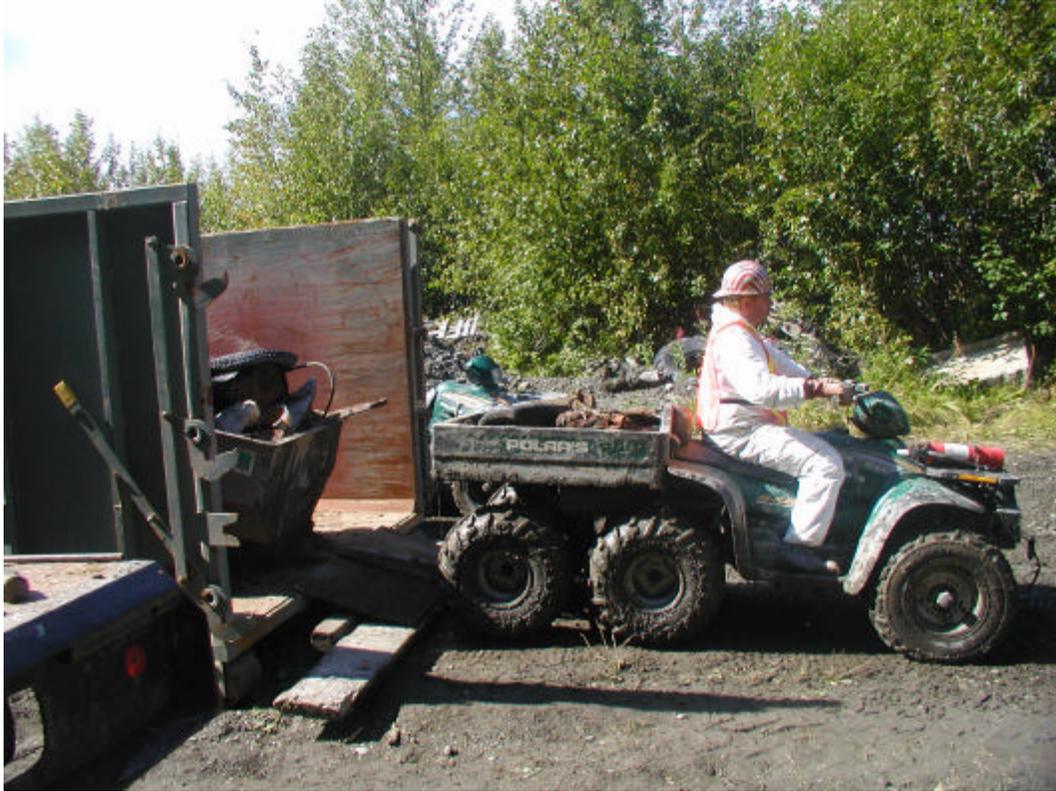
Photo 5 – Transferring Debris from ATV to Roll-off

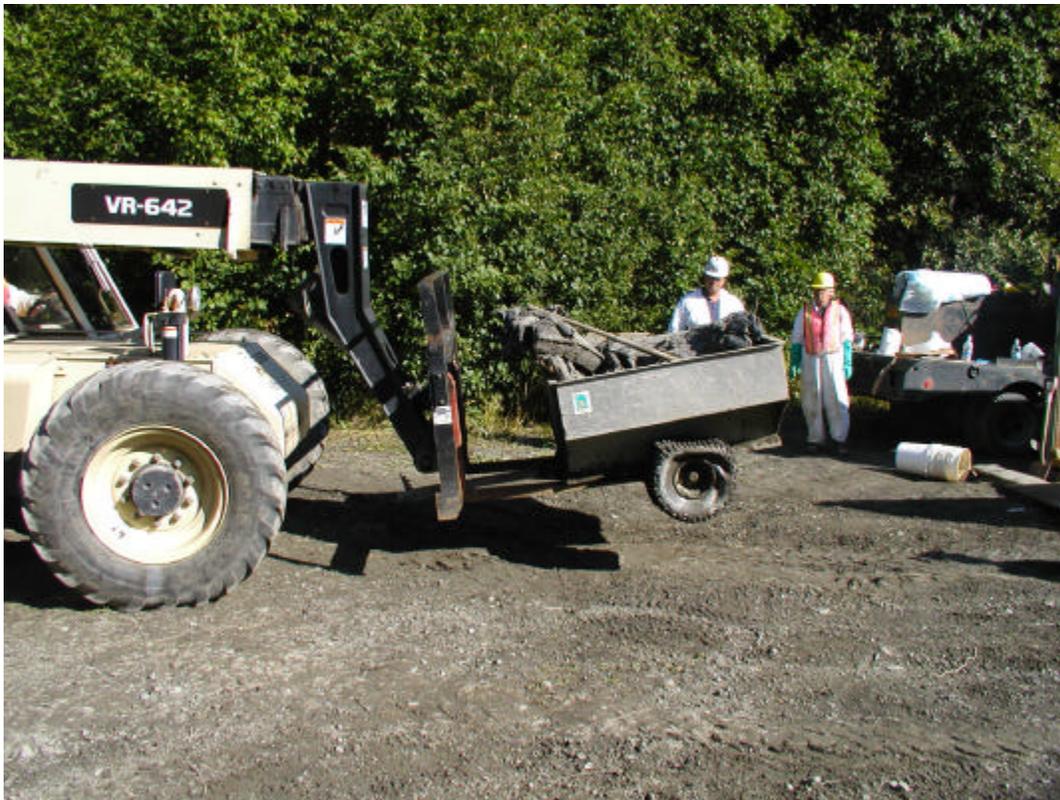
Photo 6 – Transferring Debris from Trailer to Roll-off

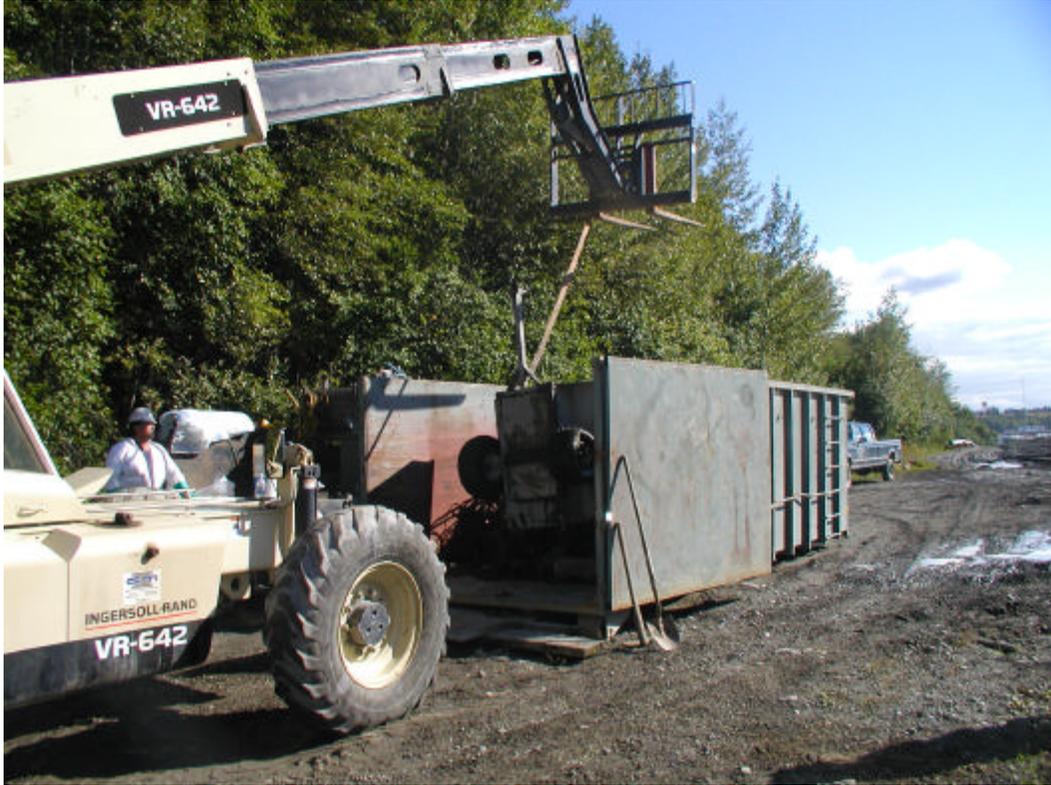
Photo 7 – Emptying Trailer Using Forklift and Strap

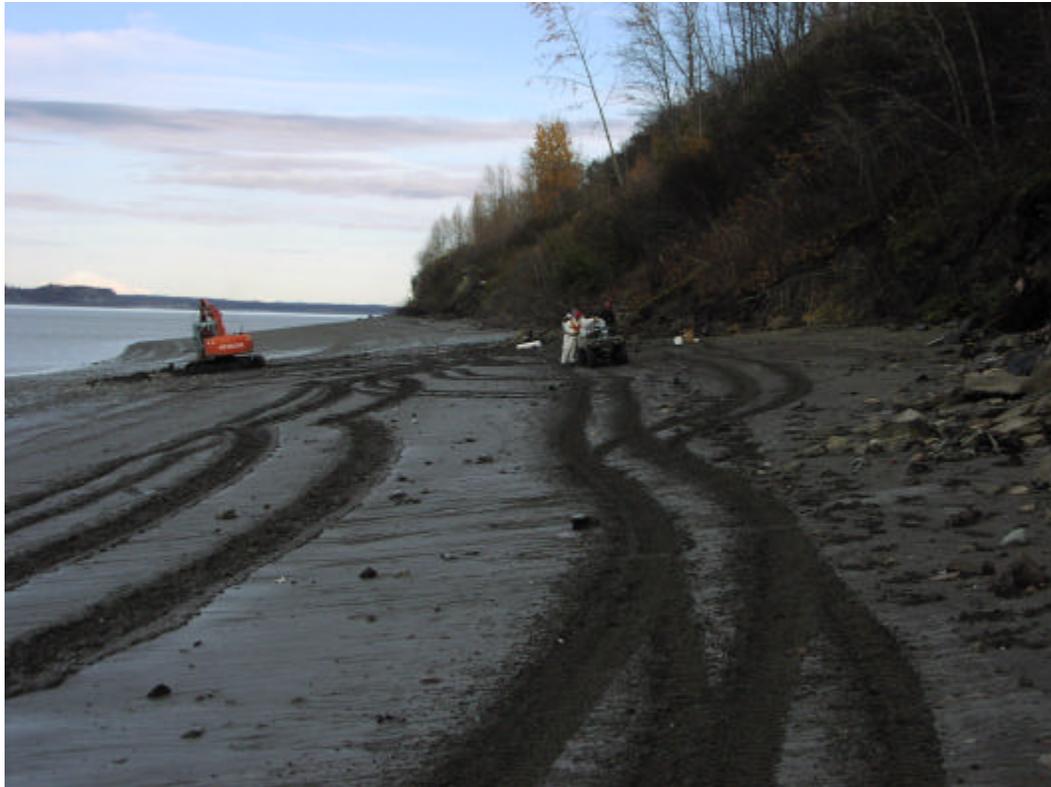
During the general debris removal in August, pipe suspected of containing asbestos was identified. Samples were taken that confirmed the presence of asbestos at 18%

Chrysotile. It was also determined that due to the weathering of the pipe; the raw asbestos bundles were friable.

Photo 8 – Asbestos Pipe Removal

An excavator was mobilized to the site to remove the surface and subsurface portions of the buried asbestos pipe. Employees involved in the handling of asbestos had received training in the proper procedures and practices for handling ACM, and had current accredited certification of asbestos training as required by federal regulations. Two ACM pipes were removed from the beach area and disposed of at the Anchorage Regional Landfill. A third ACM pipe previously identified could not be relocated during the October removal effort. Analytical results and disposal certificates for the ACM are included in Appendices B and C respectively.

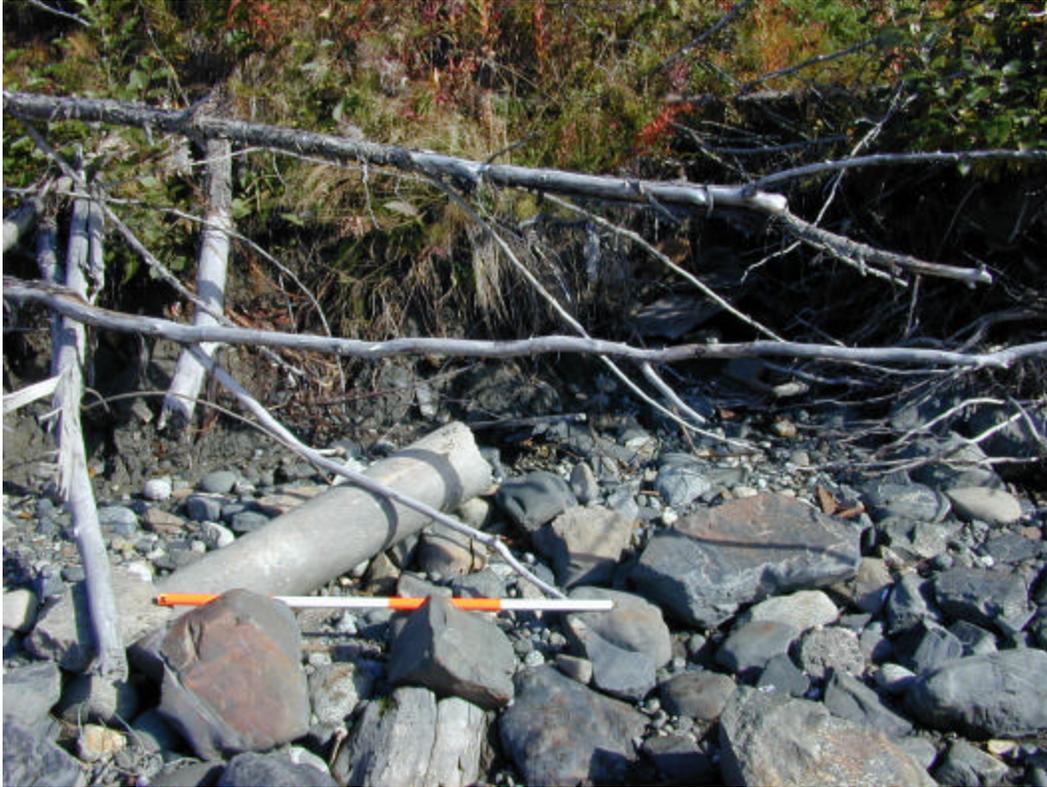
Photo 9 – Asbestos Pipe Near Foot of Bluff (Subsequently Removed)

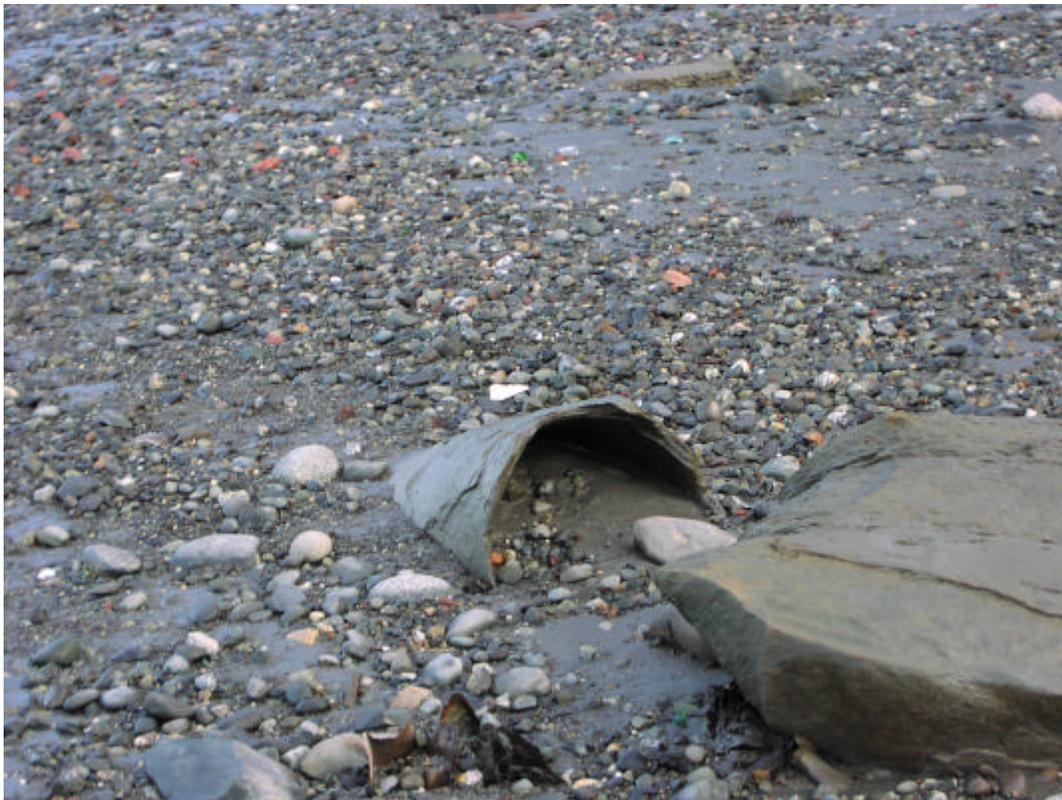
Photo 10 – Asbestos Pipe Embedded In Beach Area (Subsequently Removed)
